Siding & Trim

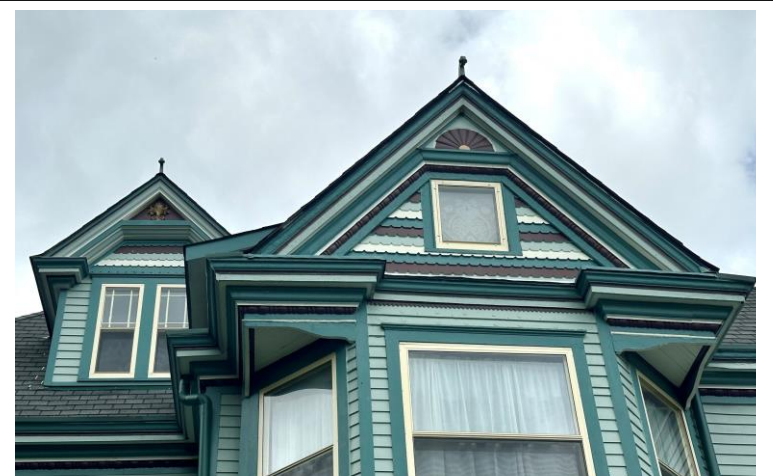
The scalloped siding and detailed gable trim on this State Street home are hallmarks of its Queen Anne architectural style.

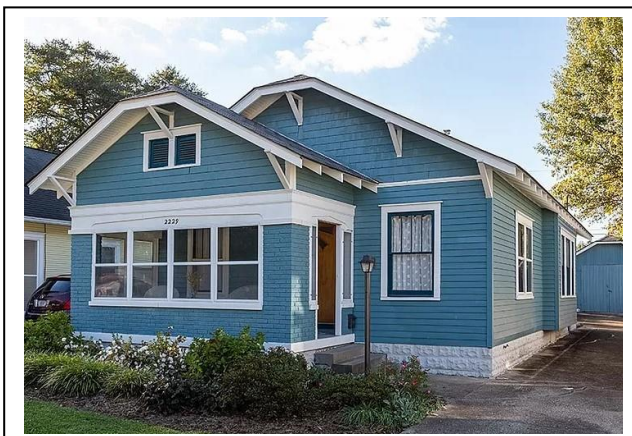
Removing the aluminum siding - and recreating the missing brackets based on ghost marks - helped to restore the character of this East Elm Street bungalow.

ST7 Removal of artificial siding and trim is highly encouraged in the district. Remove later siding carefully, to avoid damage to any historic building materials.
