Design Guidelines - Masonry

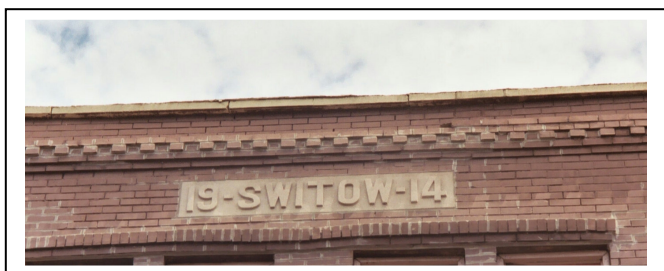
This brick corbelling is an important character-defining feature on this Pearl Street building and should be preserved.

M1 Historic masonry walls, foundations, and architectural elements such as chimneys, corbelling, cornices, columns, wall panels and arches should be preserved and maintained.

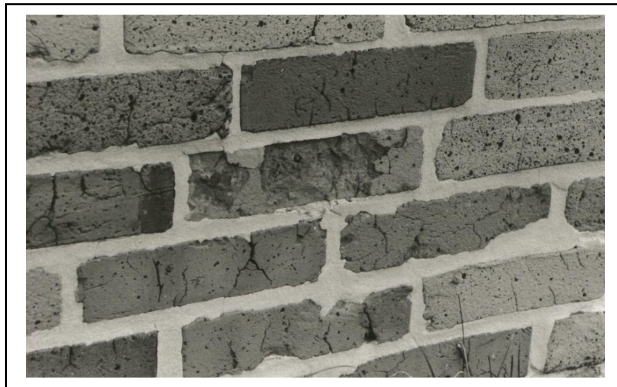
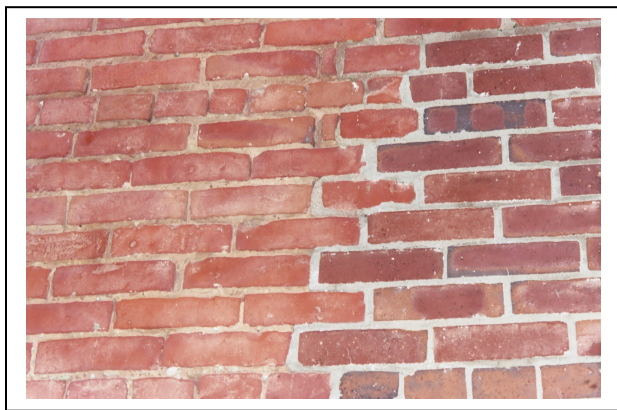
Sandblasting has damaged these bricks (top), pitting their surface and removing the fireskin. At bottom, Portland cement-based mortar used to repoint does not match the historic mortar to the left, and will eventually lead to the deterioration of the brick.

M11 Sandblasting and other abrasive cleaning methods are prohibited.

M19 Use a mortar mix that is compatible with the historic masonry. Historic mortars were high in lime content and much softer than today's Portland cement-based mortars. Repointing mortar should be equivalent to or softer than the original mortar.

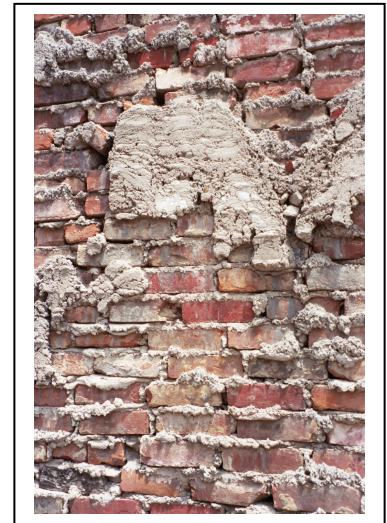
This soft interior brick was never meant to be exposed and will likely deteriorate rapidly.

M3 Make sure that any exterior replacement bricks are suitable for exterior use – some bricks were never meant to be exposed to the elements.
